## CASE STUDY

### PILOT PROJECT INSTALLED AT DUBAL, JABEL ALI, DUBAI, UAE October 20, 2017

## ASSET DETAILS:

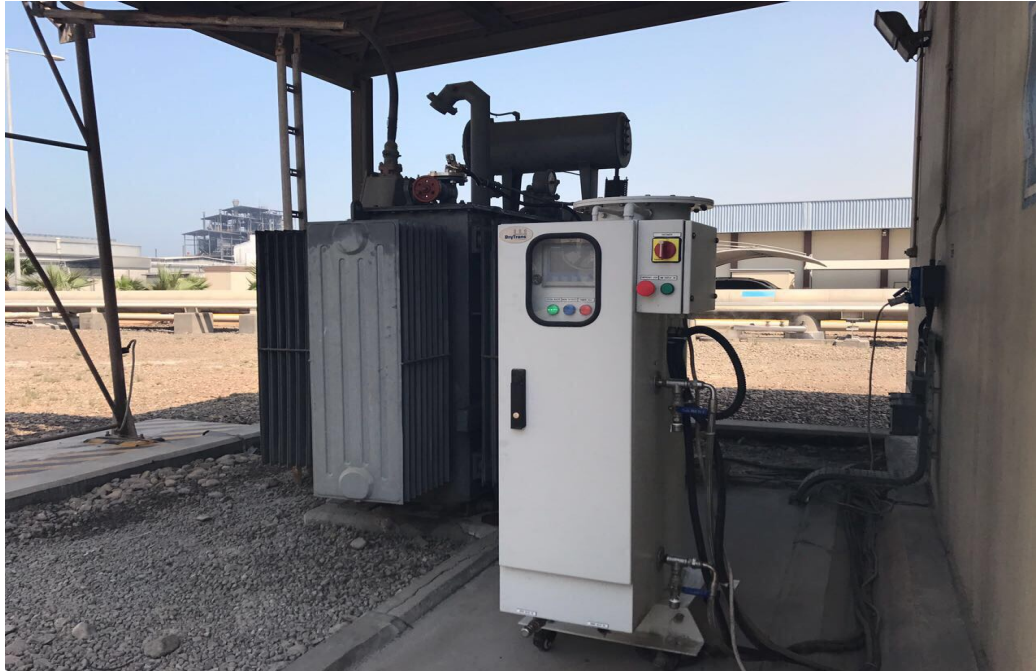
Fig 1.1 DryTrans MMS90 Installation at DUBAL Plant, Jabel Ali, UAE

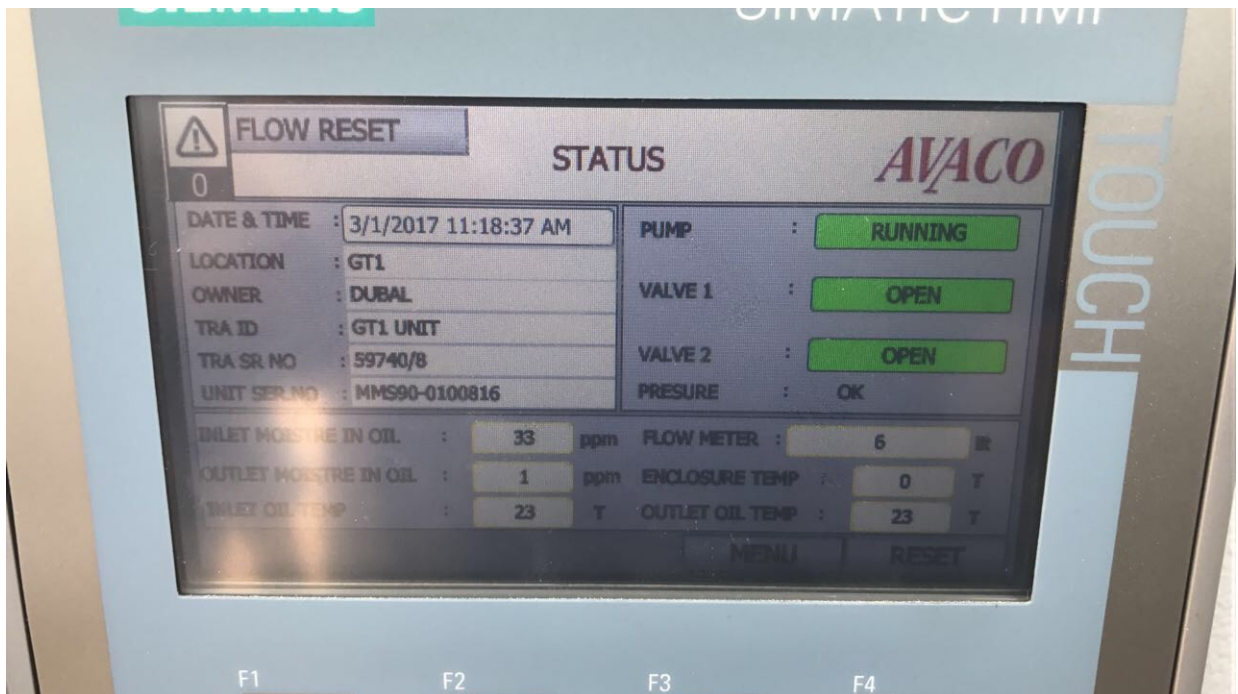
Fig 1.2 DryTrans MMS90 Installation at DUBAL Plant, Jabel Ali, UAE
