## CASE STUDY

### PILOT PROJECT INSTALLED AT DEWA POWER PLANT, JEBEL ALI, UAE JANUARY 21<sup>ST</sup>, 2018

# REPORT

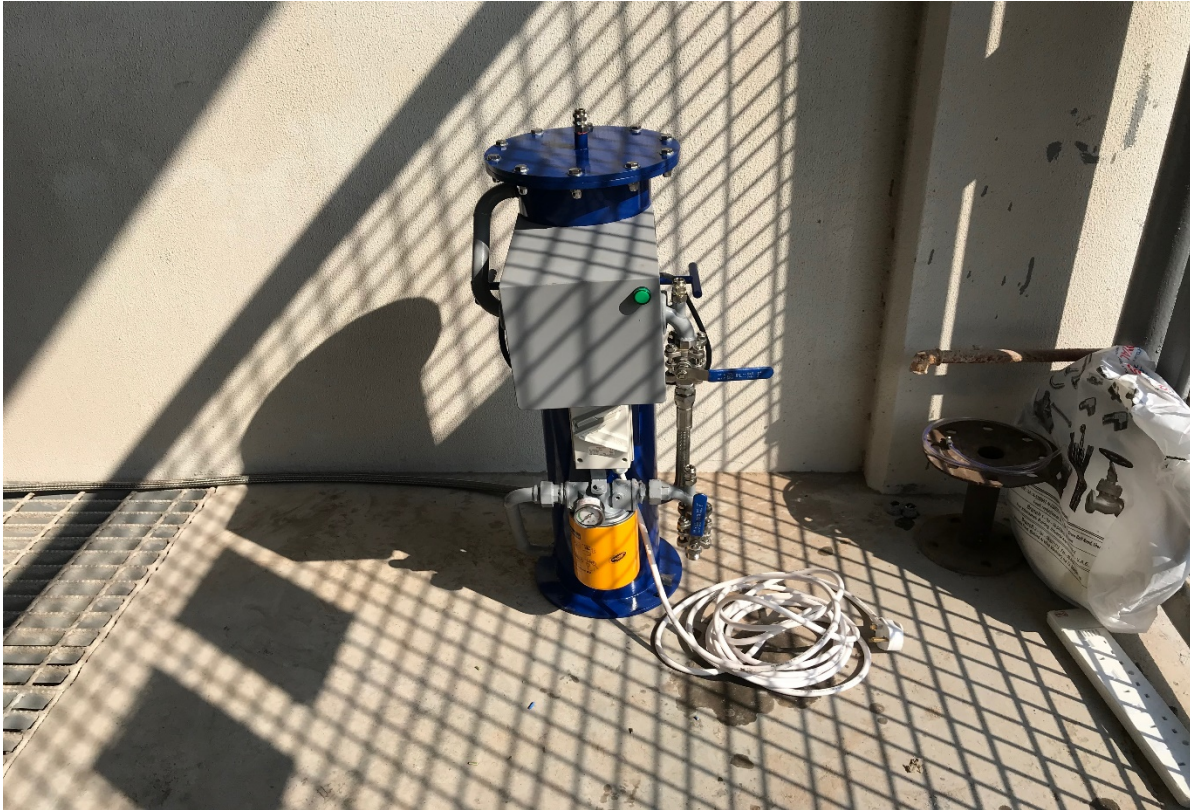
Fig 1.1 DryTrans TR5 Installation at Dewa Power Plant, Jebel Ali, UAE

AVACO has installed a pilot unit model TR5 continuous online moisture management system on BLT13-6290 T, Reactor Transformer. The TR5 has been continuously in operation since January 21<sup>st</sup> 2018.
